Manhole Inspection Summary

Manhole # S51M__057MH

Insp Date: **4/8/08 1:31 PM**

Location Address: **hudson st**

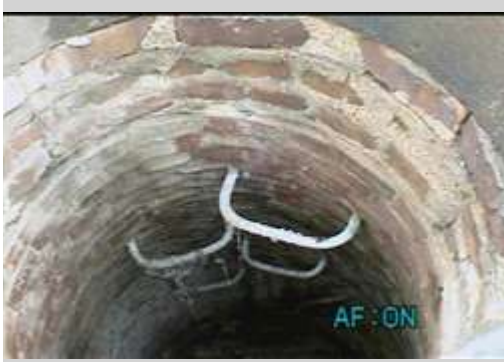
Defect 2

Count: **5** Missing: **0** ☒ Corroded

corroded steps

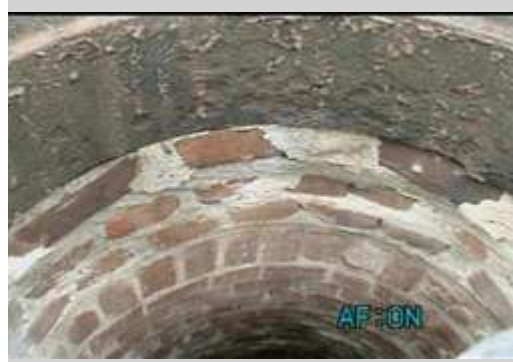
Defect 1

Infiltration: ☐ None ☐ Joint ☐ Cracks ☒ Mortar ☐ Roots ☐ Wall

chimney cond Mortar

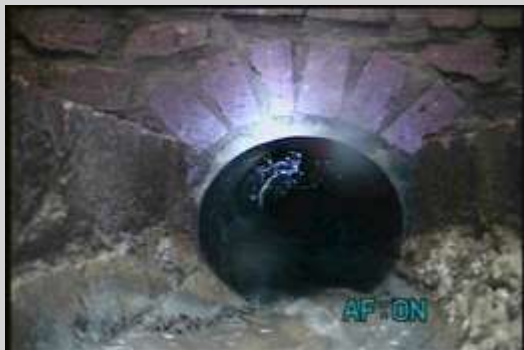
12 O'Clock Outflow

10 in. Circular Gravity Sewer
Pipe Out @ 12 O'Clock

Pipe Material: **Clay** ☐ Pipe Lined

Invert Depth: **10.70** (ft.) Flow Characteristics: **Fast**

Deposits: ☒ None ☐ Mud ☐ Sludge ☐ Debris ☐ Grease

Infiltration: **None** Pipe Seal Cond: **Unknown**

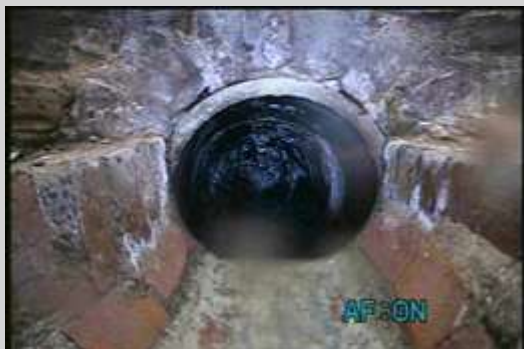
3 O'Clock Inflow

8 in. Circular Gravity Sewer
Pipe In @ 3 O'Clock

Pipe Material: **Clay** ☐ Pipe Lined

Invert Depth: **10.20** (ft.) Flow Characteristics: **Fast**

Deposits: ☒ None ☐ Mud ☐ Sludge ☐ Debris ☐ Grease

Infiltration: **None** Pipe Seal Cond: **Unknown**

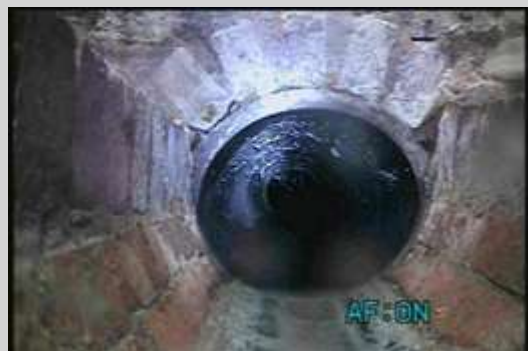
6 O'Clock Inflow

10 in. Circular Gravity Sewer
Pipe In @ 6 O'Clock

Pipe Material: **Clay** ☐ Pipe Lined

Invert Depth: **10.60** (ft.) Flow Characteristics: **Fast**

Deposits: ☒ None ☐ Mud ☐ Sludge ☐ Debris ☐ Grease

Infiltration: **None** Pipe Seal Cond: **Unknown**
